WRC Related Activities at GSI

- Short Overview
- Timing Receiver Node Form Factors
- New Form Factors
- What About WRPC v5?
- WR Switch firmware

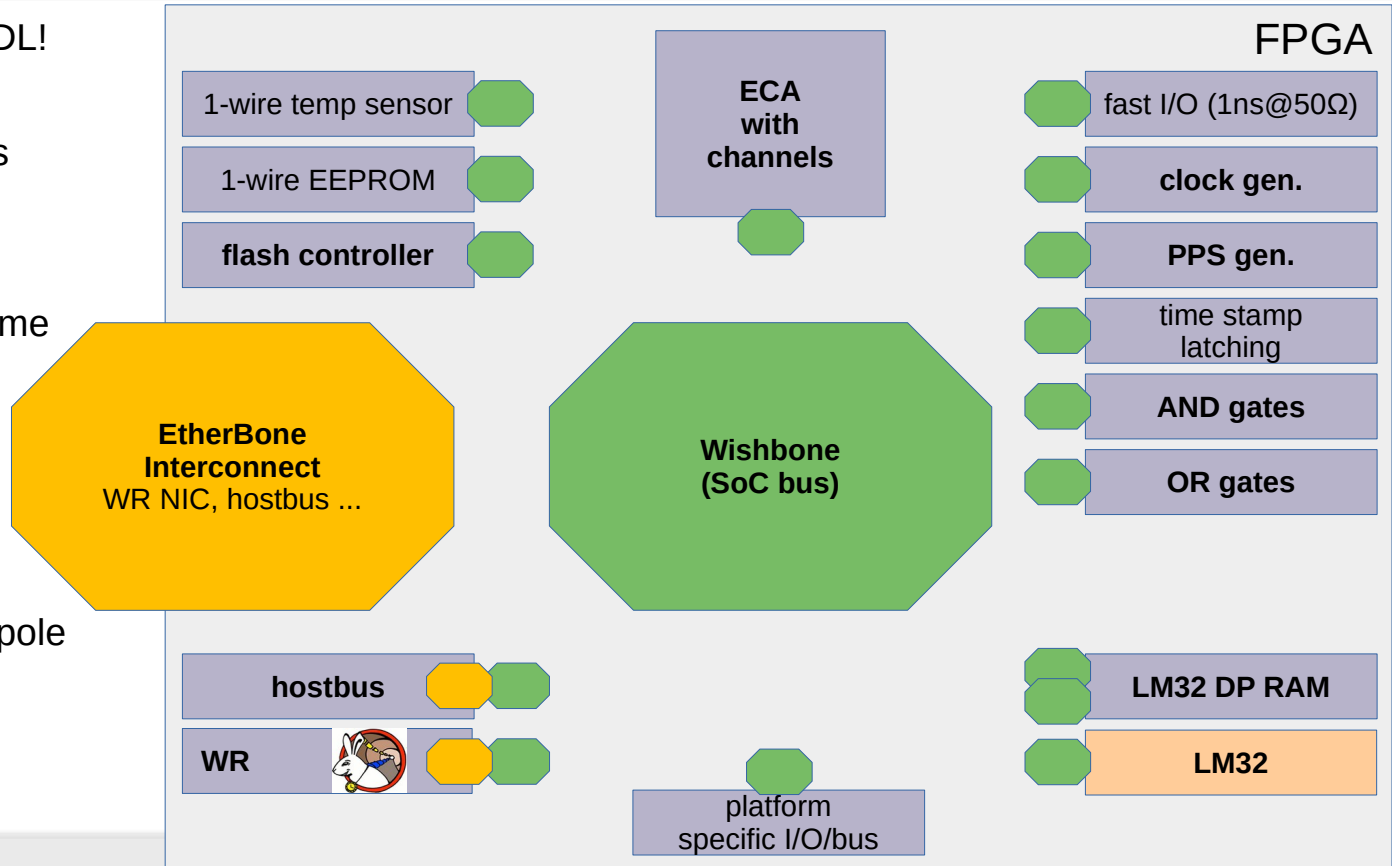
Common Features for Timing Receiver Nodes 'Everything Happens in the FPGA'

no application specific VHDL!

instead:

- configuration of IP cores
- ECA
- LM32 user softcore:

upload binaries at run-time
(c-code, OS-less)

hard real-time

synchronosly at
many nodes

example: ramping up dipole
magnet current or
rf-cavity frequency

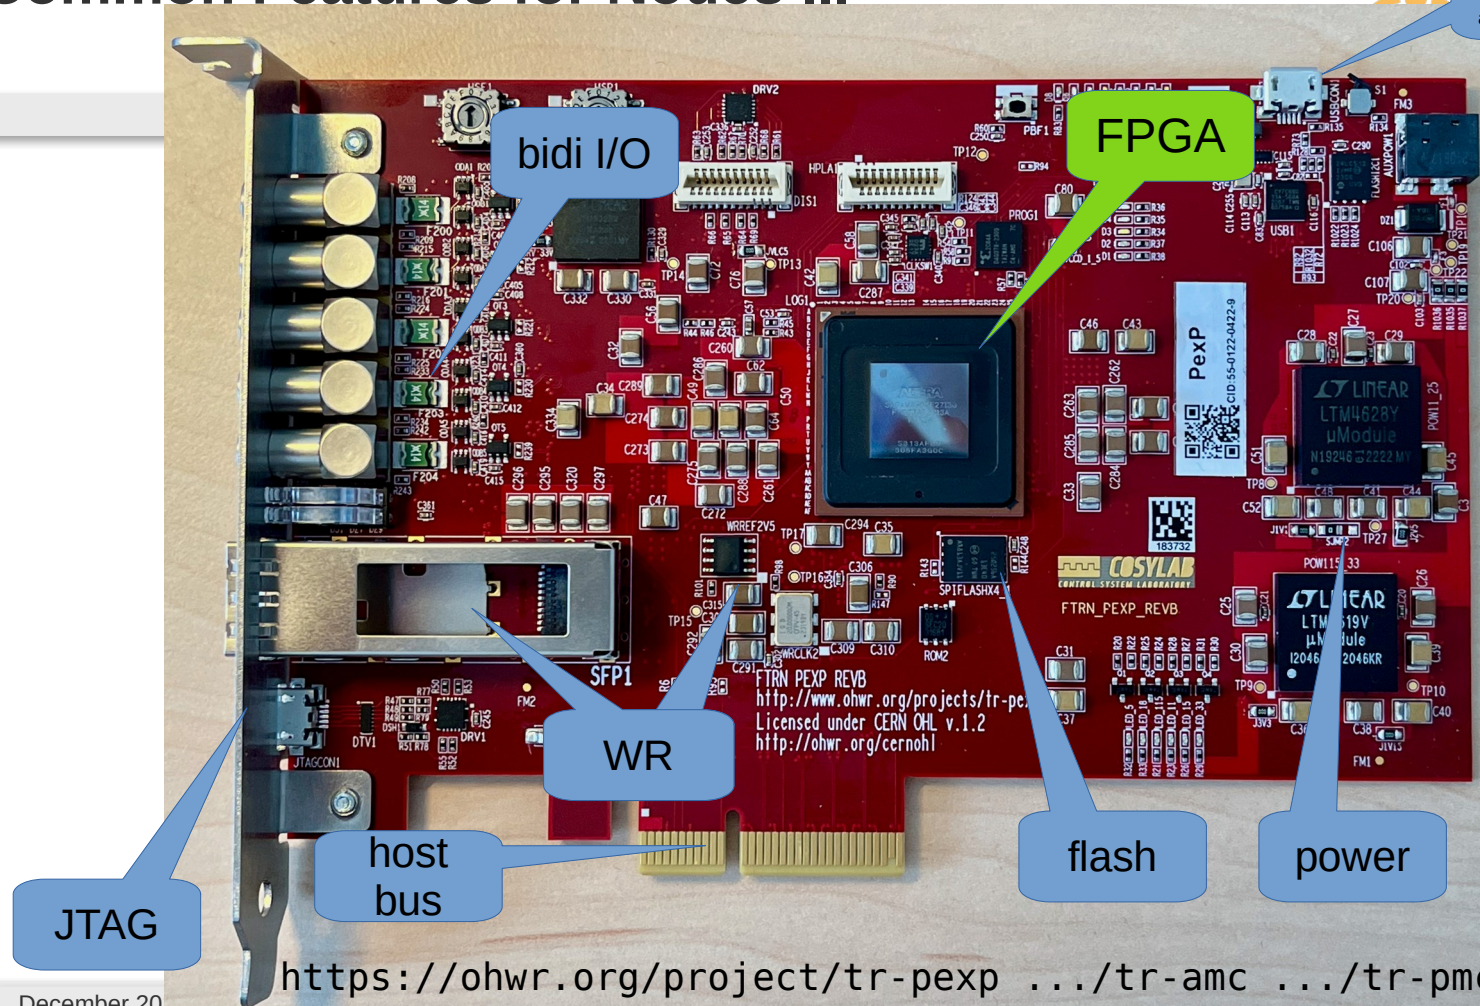
Common Features for Nodes ...

USB
another hostbus

<https://ohwr.org/project/tr-pepx> .../tr-amc .../tr-pmc

- 67 69 (104 107) [333] WR switches for facility operation (in use) [on-site]
 - mainly Creotech and Seven Solutions, some SyncTechnology
 - v6.1 for all operational WRS
 - SFP, mainly CBO with DDM
- 332 (416) [2296] WR nodes for facility operation (in use) [on-site]
 - OHWR: TR-PMC, TR-AMC, TR-PEXP; in-house: **SCU** (**S**calable **C**ontrol **U**nit, workhorse)
 - Arria V GX, Arria II GX
 - wrpc-v4.2
 - https://github.com/GSI-CS-CO/bel_projects, current release v6.3.1 ,fallout'
- host systems
 - SCU: COM Express
 - non-SCU: uTCA, VME, IPC (1U), Server-PC, other
 - PXE boot of ,ACO-Ramdisk' for **A**ccelerator **C**ontrol system
 - other

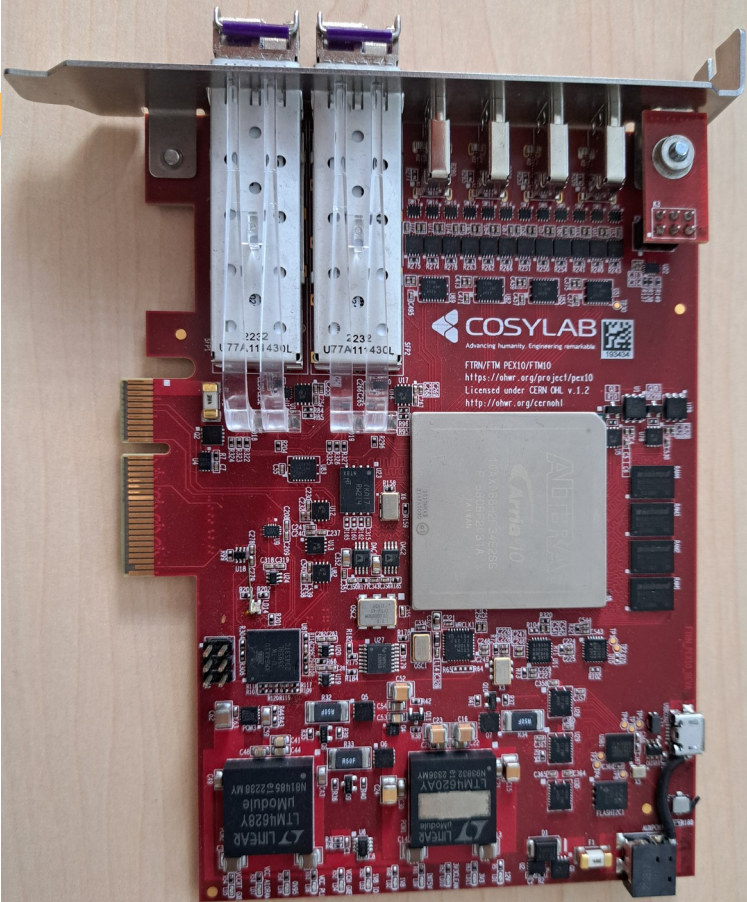
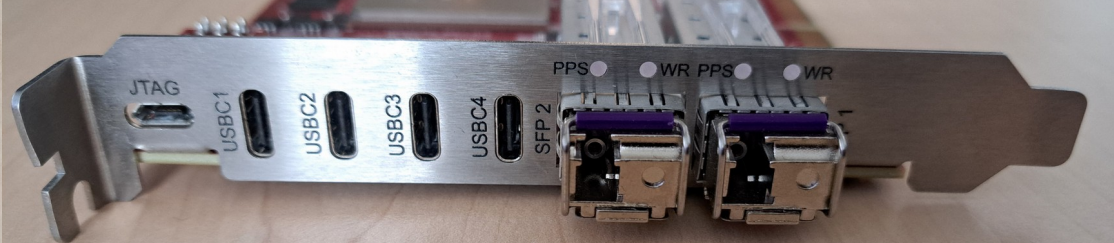
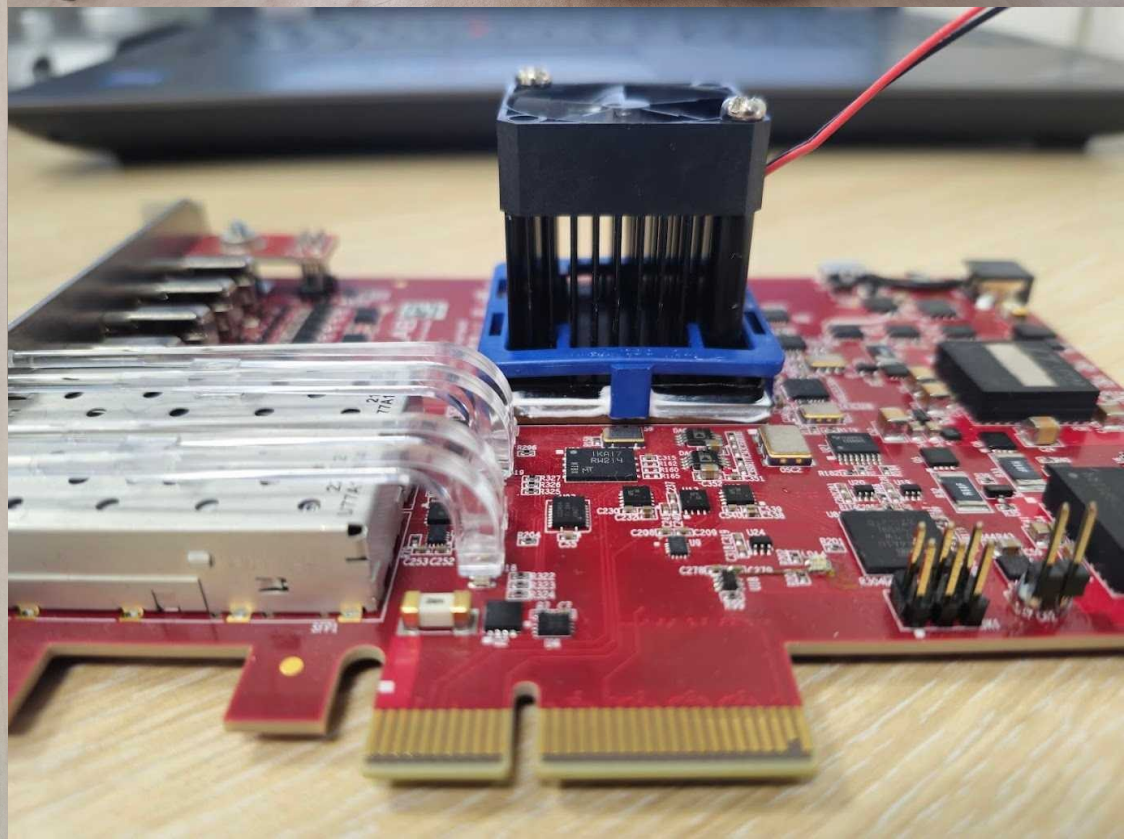
- SCU5
 - successor of SCU3, standard front-end controller for FAIR
 - in-house development
 - Pexarria10, two versions with different FPGA sizes
 - small: node version with one SFP/White Rabbit interface, 2 user soft cores

- large: "Data Master" version with two SFPs/White Rabbit interfaces, 8+ user soft cores
 - same FPGA footprint for both
 - open source project on OHWR/GitHub/GitLab

- A10 TR to be contributed to WRC; relevant repos general-cores, wrpc-sw, wr-cores
- issues
 - when the large FPGA is used, heating is a major issue
 - dual White Rabbit kills PCIe, hard to fix, according to Intel/Altera problems inside the transceiver banks
 - 1ns LVDS IOs do not work yet
 - prime feature for TR nodes at GSI/FAIR (we don't use 'fine-delay' modules)
 - 1ns granularity achieved by using differential 1Gbit transceivers
 - time stamping
 - pulse generation
 - porting from Quartus 18 to Quartus 23 requires a new hardware revision (clocking)
 - only one 3V bank (not 3.3V!) -> level shifter madness

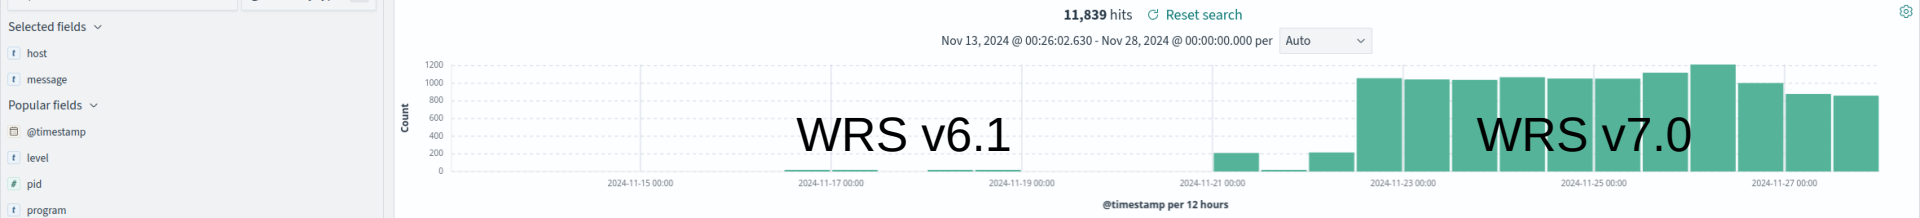
- 21-22 Nov 2024: firmware update of all 107 White Rabbit switches from v6.1 to v7.0
- required changes in dot-config and new calibration parameters
- worked out very well
- only issue so far
 - „Error wrsSwcoreStatus: Endpoint TX frames number (462775) on port 10 (wri 10) does not match the number of frames forwarded from other ports (134005) and NIC (1090), some frames got lost... Difference is **more than 5**, since last check (293s)“
 - false positive
 - issue shows up only in a dedicated network with frame rates 1.5 ... 2.5 kHz
 - v6.1: less than 10 occurrences per **week**
 - v7.0: more than 100 occurrences per **hour**
 - proposal: configurable limit via dot-config (presently fixed limit of 5 frames)
- BTW: are there new calibration values for the fanless WRS from SynchTech?

Time	host	message
> Nov 27, 2024 @ 23:59:28.023	nwt0285m6	SNMP: Error wrsSwcoreStatus : Endpoint TX frames number (458646) on port 7 (wri 7) does not match the number of frames forwarded from other ports (326488) and NIC (1885), some frames got lost... Difference is more , since last check (291s)
> Nov 27, 2024 @ 23:59:28.022	nwt0285m6	SNMP: Error wrsSwcoreStatus : Endpoint TX frames number (458628) on port 3 (wri 3) does not match the number of frames forwarded from other ports (391997) and NIC (1095), some frames got lost... Difference is more , since last check (291s)
> Nov 27, 2024 @ 23:59:28.020	nwt0285m6	SNMP: Error wrsSwcoreStatus : Endpoint TX frames number (458598) on port 2 (wri 2) does not match the number of frames forwarded from other ports (391997) and NIC (1065), some frames got lost... Difference is more , since last check (291s)
> Nov 27, 2024 @ 23:58:56.653	nwt0291m6	SNMP: Error wrsSwcoreStatus : Endpoint TX frames number (468202) on port 14 (wri 14) does not match the number of frames forwarded from other ports (278519) and NIC (1075), some frames got lost... Difference is more 5, since last check (296s)

> Nov 27, 2024 @ 23:57:55.486	nwt0292m6	SNMP: Error wrsSwcoreStatus : Endpoint TX frames number (468481) on port 6 (wri 6) does not match the number of frames forwarded from other ports (393861) and NIC (1084), some frames got lost... Difference is more , since last check (292s)
> Nov 27, 2024 @ 23:57:10.249	nwt0100m6	SNMP: Error wrsSwcoreStatus : Endpoint TX frames number (462440) on port 10 (wri 10) does not match the number of frames forwarded from other ports (395829) and NIC (1075), some frames got lost... Difference is more 5, since last check (293s)
> Nov 27, 2024 @ 23:57:10.248	nwt0100m6	SNMP: Error wrsSwcoreStatus : Endpoint TX frames number (462452) on port 9 (wri 9) does not match the number of frames forwarded from other ports (395829) and NIC (1087), some frames got lost... Difference is more , since last check (293s)
> Nov 27, 2024 @ 23:54:29.781	nwt0285m6	SNMP: Error wrsSwcoreStatus : Endpoint TX frames number (393225) on port 6 (wri 6) does not match the number of frames forwarded from other ports (457677) and NIC (1084), some frames got lost... Difference is more , since last check (290s)
